Manhole Inspection Summary

Manhole # S43A__030MH

Record Plat: **43A** Node: **030** Status: **Found**

Location Address: **BROADWAY**

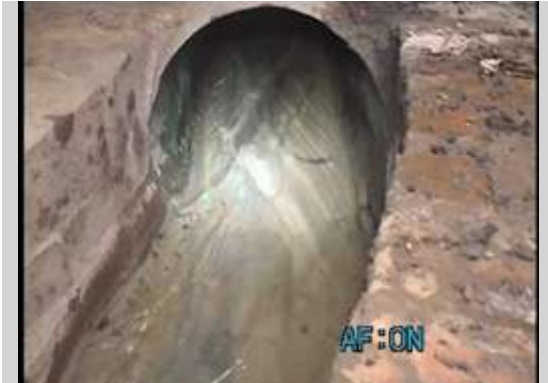
12 O'Clock Outflow

12 in. Circular Gravity Sewer
Pipe Out @ 12 O'Clock

Pipe Height: **12** (in.) Rod and Bar (Angled)
Pipe Material: **Clay** ☐ Pipe Lined
Invert Depth: **6.25** (ft.) Flow Characteristics: **Slow**
Deposits: ☒ None ☐ Mud ☐ Sludge ☐ Debris ☐ Grease
Silt Depth: (in.) Deposits Extent:
Infiltration: **None** Pipe Seal Cond: **Sound**

Drop: **None**

Connects To: **Manhole**

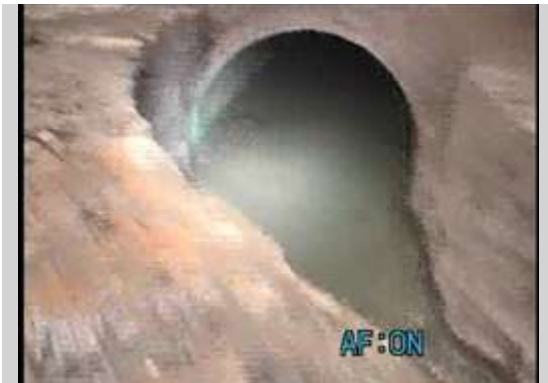
9 O'Clock Inflow

12 in. Circular Gravity Sewer
Pipe In @ 9 O'Clock

Pipe Height: **12** (in.) Rod and Bar (Angled)
Pipe Material: **Clay** ☐ Pipe Lined
Invert Depth: **6.35** (ft.) Flow Characteristics: **Slow**
Deposits: ☒ None ☐ Mud ☐ Sludge ☐ Debris ☐ Grease
Silt Depth: (in.) Deposits Extent:
Infiltration: **None** Pipe Seal Cond: **Sound**

Drop: **None**

Connects To: **Manhole**
